# Merced River Salmon Habitat Enhancement Project Phase III - Robinson Reach

## Final Engineering and Construction Report

August, 2002

California Department of Water Resources  
San Joaquin District  
River Management Section

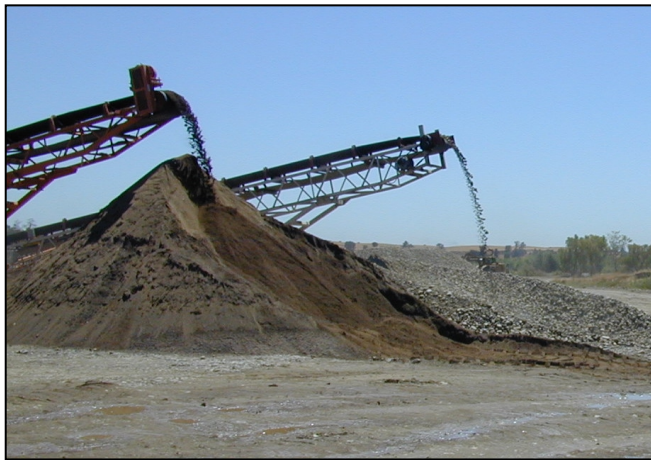
**Figure 3 – Gravel Screening Plant**

During the month of July, much of the levees and abandoned channel area from 88+00 to 111+00 were transformed into rough floodplain, but work by then had begun in several other areas of the project as well. After the crossings were functional, work began on the remaining levee system throughout the project. Levees were reduced to floodplain elevation and the material was used to fill nearby low areas. At the same time, the push to fill a large flat area between stations 32+00 and 72+00 began, and by the end of the month the gravel screening plant became operational. The contractor set up the plant on the point bar near station 27+00 and began screening spawning sized gravel to be used later in the design channel (Figure 3).

station 27+00 and began screening spawning sized gravel to be used later in the design channel (Figure 3).

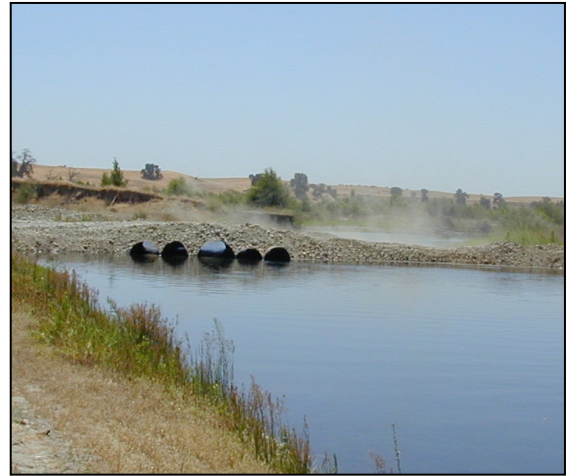
**Figure 2 – Culvert Crossing Construction**

The initial cut and fill of the project area began on the first day of construction, July 11<sup>th</sup>, 2001. As levees began to be excavated, culvert crossings also began to be constructed to provide access to all areas of the project (Figure 2). Three crossings were eventually installed, each in areas where the existing river channel crossed the design channel. The crossing at station 88+00 was the first to be constructed, followed by one at station 31+00 and another at 115+00 (see Appendix A, Sheet A1). These crossings became essential in keeping the river as clean as possible during construction. Cut and fill work began near the 88+00 crossing and worked downstream along the levees and former river channel (see Appendix B, Sheet B1).

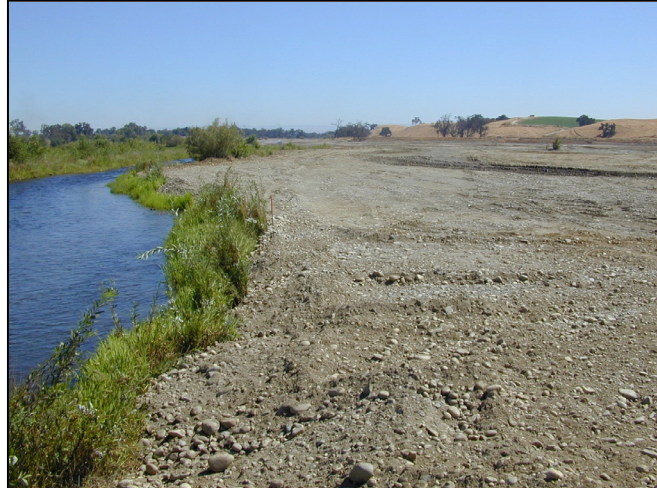
**Figure 4 - Floodplain Fill and Existing Channel**

In August, the remainder of shallow wet areas near the Hwy 59 bridge were filled, and part of the large, deep pond on the south side near station 79+00 was filled, but the majority of the contractor's work centered on filling between stations 32+00 and 72+00. They left a narrow channel through this section for the existing river to flow, which made filling each side a separate operation (Figure 4). At the same time, the contractor began excavating a large portion of the abandoned point bar upstream of station 32+00, referred to as "Borrow Site 2", and the terrace on the south side of the project between stations 45+00 and 50+00 (Borrow Site 3) (see locations in Appendix A, Sheet A1). They used the material from both sites to fill the low areas mentioned above and to supply the gravel screening plant.

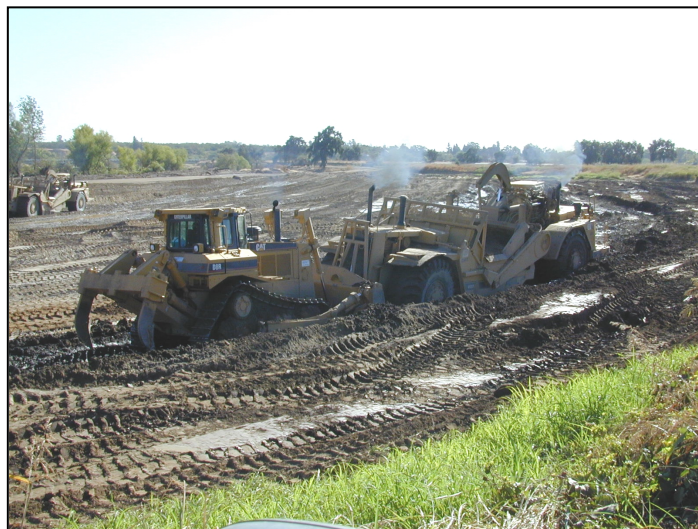
**Figure 5 - Borrow Site 1 Excavation**

The existing river channel between stations 90+00 and 100+00 was crowded to the south as much as possible to make room for the design channel work. In addition, the terrace on the north side at stations 90+00 to 110+00, referred to as "Borrow Site 1", began to be excavated to floodplain elevation (Figure 5). Overburden from this area was first moved to the south side of the river and stockpiled on the bluffs between stations 97+00 and 105+00 for later use in filling the adjacent pond. The Borrow Site 1

material exposed when the overburden was removed consisted largely of gravel deposits and was used in the design channel and haul road construction.

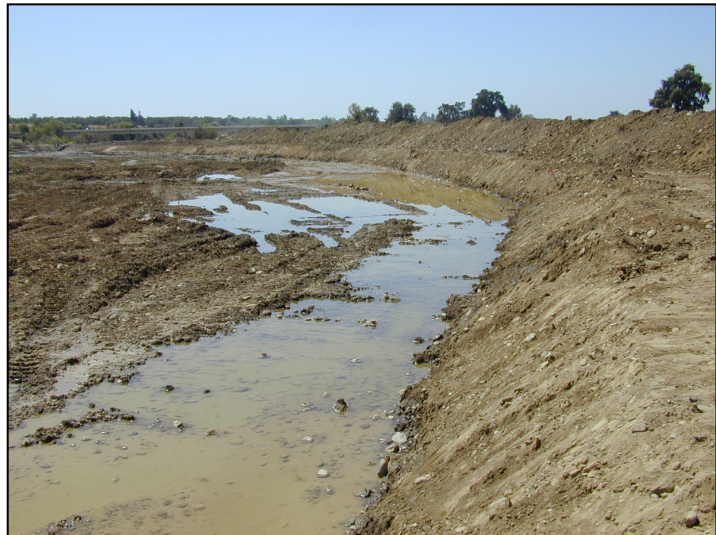
**Figure 6 - Overexcavation**

Construction of the channel began in mid-August near the downstream end of the project, station 112+00 (see Appendix B, Sheet B3). Most of the random fill adjacent to the channel in that area, which was necessary before channel excavation could begin, was in place by then. From there, the channel was overexcavated upstream to approximately station 99+00 after engineers determined that inadequate material surrounded the channel (Figure 6). Select material was subsequently placed, and this reach was complete by early September.

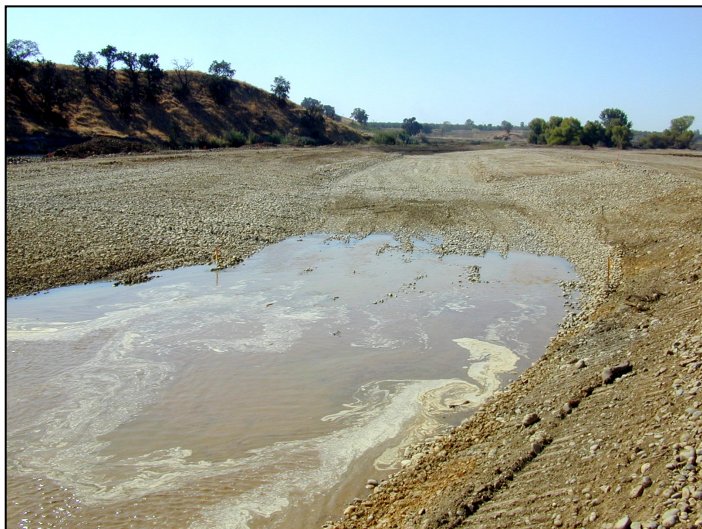
**Figure 7 – Diversion of River To Design Channel**

By the end of September, excavation had begun on most of the channel downstream of station 38+00, but the contractor focused on finishing the section from station 90+00 downstream so that the river could be diverted to the new channel. This step was also required before the large pond near station 108+00 could begin to be filled. By the end of September all of the select and graded material had been placed in that reach. After

finish grading the riffles to within tolerance, the section was approved and the river was diverted to the new channel from stations 90+00 to 114+00 (Figure 7).

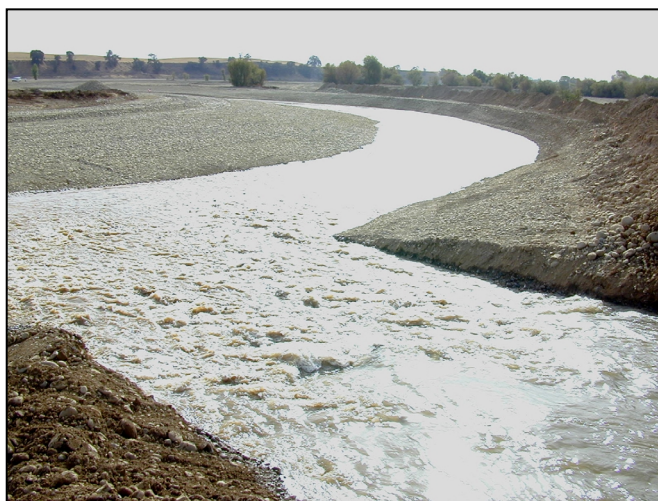
**Figure 8 - Diversion at Station 55+00**

By that time the contractor had placed most of the select material from stations 42+00 to 81+00, and had begun placing graded material from 54+00 to 78+00. Graded placement from 78+00 to 86+00 was begun in early October, and by October 15<sup>th</sup> the channel from 55+00 to 90+00 was complete. The river was then diverted to the new

channel at station 55+00 after all culvert crossings had been removed and the channel between 88+00 and 115+00 had been completed (Figure 8).

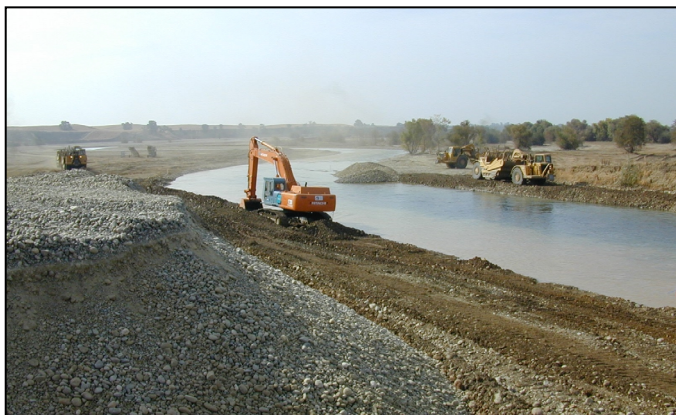
**Figure 9 – In-Water Work**

The final stage of channel construction, from 24+00 to 38+00, was done in the

water under flows of about 700 cfs (Figure 9). Since material quality was high in this reach, inspectors did not require overexcavation, and the section was completed by the deadline of October 31<sup>st</sup> for in-water work. The backwater channel, which meets the design channel at station 79+50, was completed at about the same time. After the large pond was filled on either side of it, the other end of the channel had to be excavated through the floodplain. The portion which runs through the area of the

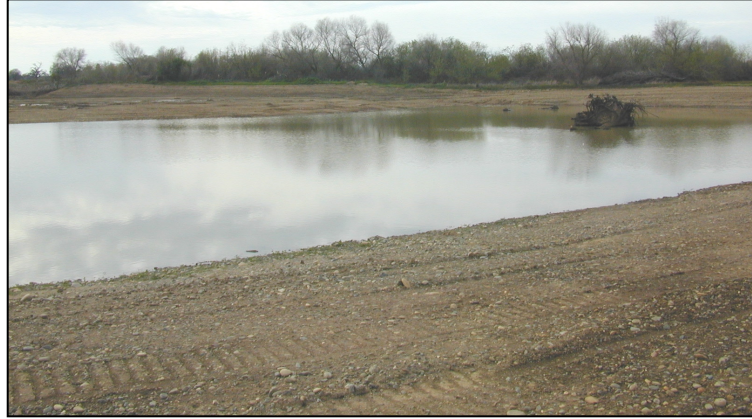
**Figure 10 – Portion of Completed Design Pond**

Final grading of the floodplain was an ongoing process which essentially started at about the time the design channel was completed. It included not only grading the floodplain to specified tolerances of plus or minus 0.3 feet, but also finishing features such as Simulated Abandoned Channels, the floodplain terrace, and the pond and its islands (Figure 10).
